FCO #512-00221A Modified Plate Support Wheel

Document number: 719-00392A-EN Rev A

MCU for Lotem® 400

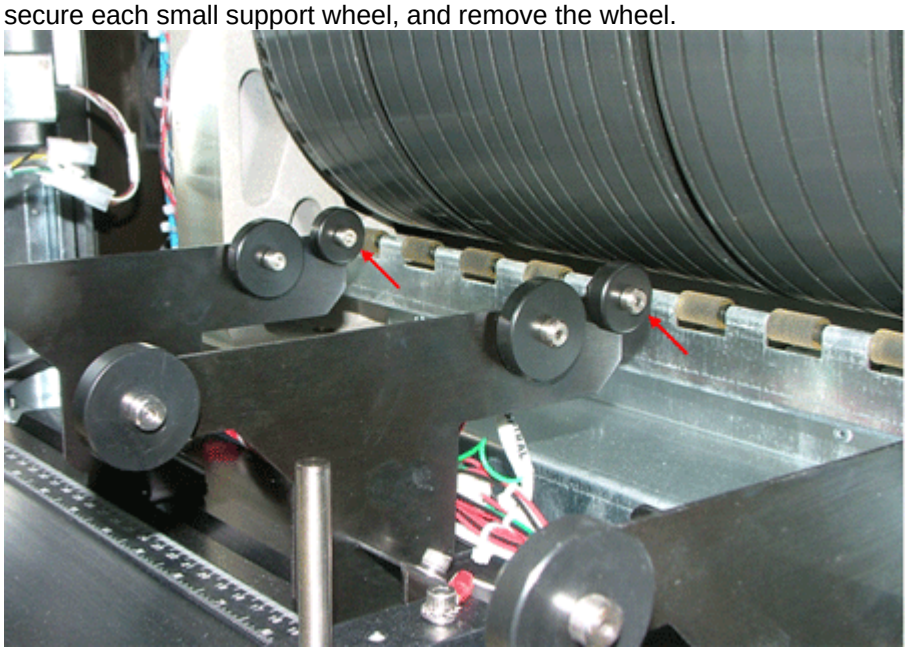
When the XY bar lowers the plate for loading onto the drum, the plate hits the support wheels nearest the drum and cannot obtain the position near the drum to be loaded.

Replace the support wheels nearest the drum with the new, smaller wheels.

1. With the MCU disconnected from the platesetter and from the power, remove the hex screws that secure each small support wheel, and remove the wheel.

2. Install the new support wheels and secure them with the screws you removed in step 1.
