Replacing the Cassette Plenum Rail

Document number: 512-00189A

Product	FCO priority
Magnus VLF Autoloader	Next failure

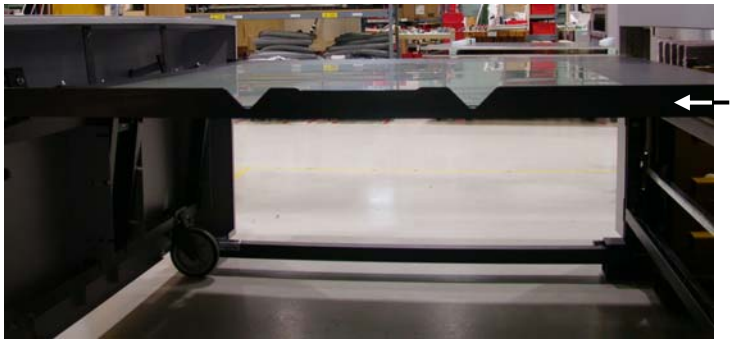
The MCU cassettes are catching on the plenum rollers and are difficult to load into the MCU. The new plenum rails can be identified by the beveled edge on the side closest to the MCU.

Old cassette plenum rail

New cassette plenum rail

Replace the plenum rail on all cassettes.

1. Open the MCU cart with the cassette loaded that needs to be upgraded.
2. Remove the existing plenum rail.

3. Install the new plenum rail.
4. Close the MCU cart and load the cassette into the MCU.
