Kodak

Magnus VLF
Installation Feedback Report Form

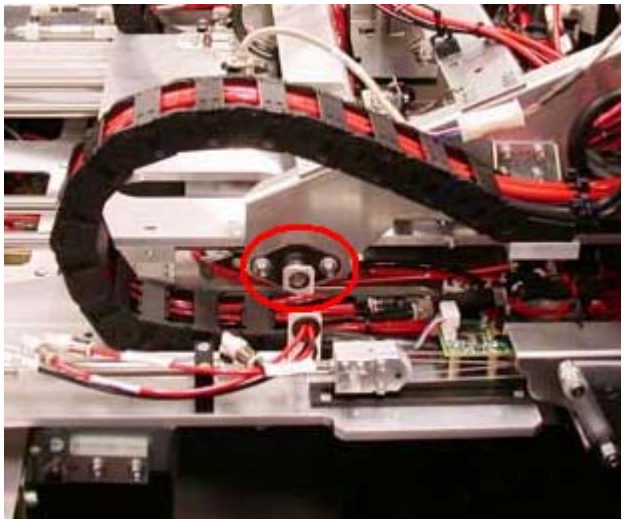
Description of problems encountered	The steel nut inclined. The sensor was damaged.
Description of causes	Trouble in factory or movement.
Description of solutions	Re-install the JACK screw nut and adjusted it.
Additional comments or suggestions
