FCO 512-00386A: Anti-noise Foams Kit For ThermoFlex Mid II Platesetter

Document number: 719-00733B-EN Rev B

Applies to	Kodak® ThermoFlex® Mid II	**Priority:** Next failure
Component	Side doors and rear panel

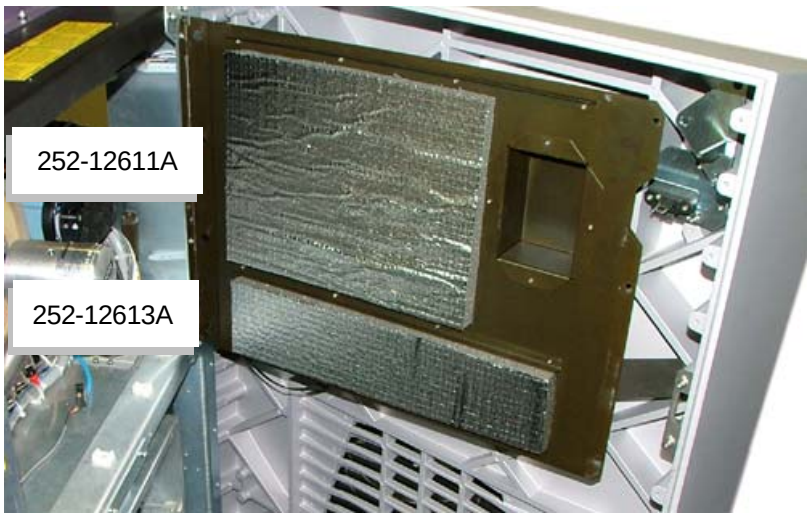
Right side door without foam attached

Right side door with foam units attached. The black foam units (252-12612A and 252-12614A) are underneath the silver foam units (252-12611A and 252-12613A).

1. In the ThermoFlex Controller software, open the loading table.
2. From the front of the platesetter, access the side doors:
   a. Slide open the loading tray.
   b. Open the front panel.
   c. Open the side doors.
3. On the right side door, attach the black upper foam unit (252-12612A) and thin black lower foam unit (252-12614A) to the door, and then attach the silver upper foam unit (252-12611A) and silver lower foam unit (252-12613A) to the black foam units, as shown.

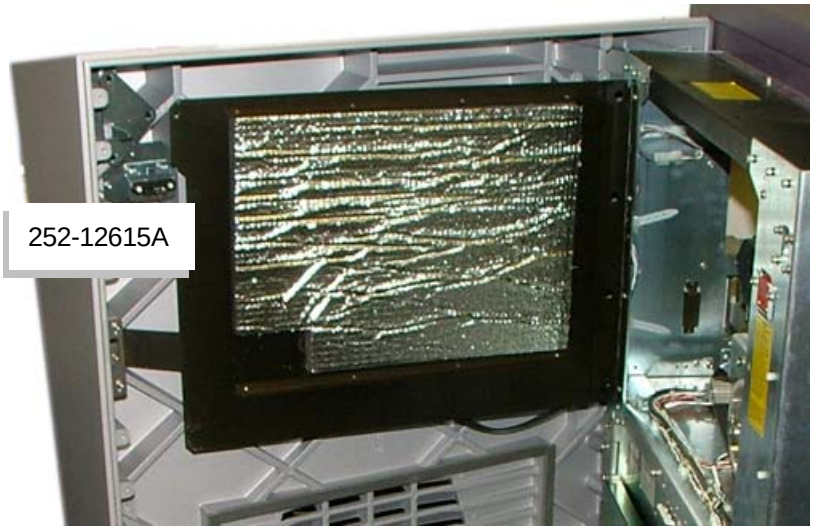
Left side door without foam attached

Left side door with foam units attached. The black foam unit (252-12616) is underneath the silver foam unit 252-12615A.

4. On the left side door, attach the thin black foam unit (252-12616A) to the door, and then attach the silver foam unit (252-12615A) to the black foam unit, as shown.
