Installing the Diagnostic Cable Bracket

Applies to ThermoFlex, prior to FX36

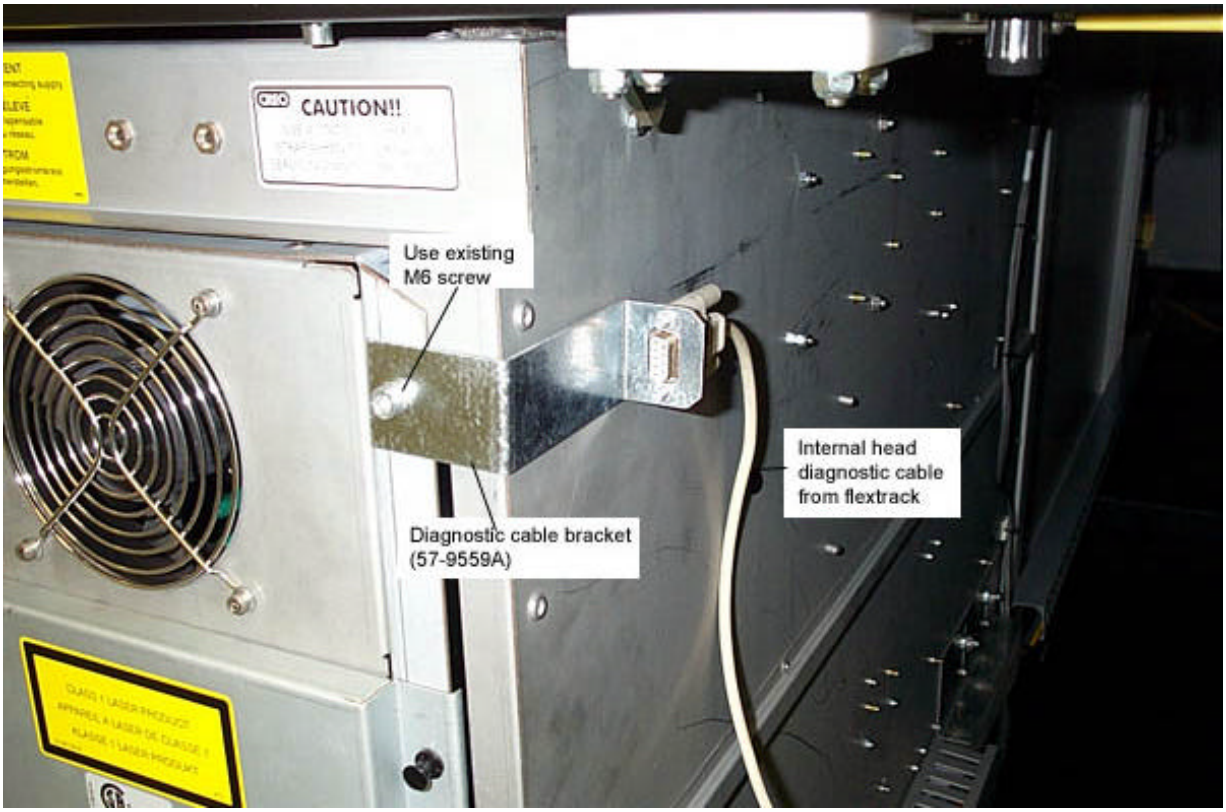
Background Head focus problems may occur if the head diagnostic cable that is mounted inside the machine is not grounded. A bracket is being factory installed on all machines from FX36 on, but should also be field installed on any earlier machine that has head focus problems.

Figure 1: Power box with diagnostic cable bracket attached

1. Attach the bracket to the power box, as shown in Figure 1.
   Use the existing M6 screw; apply Loctite when reattaching it.
